San Jacinto River Waste Pits Superfund Site

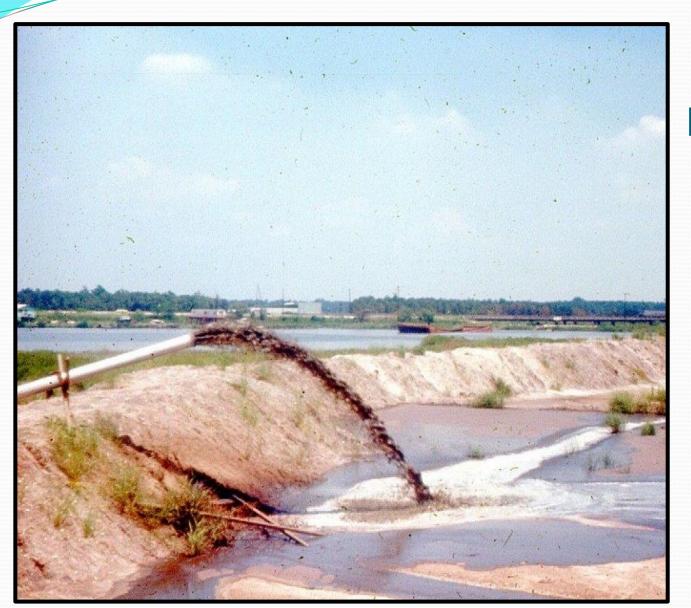
South Impoundment 1965

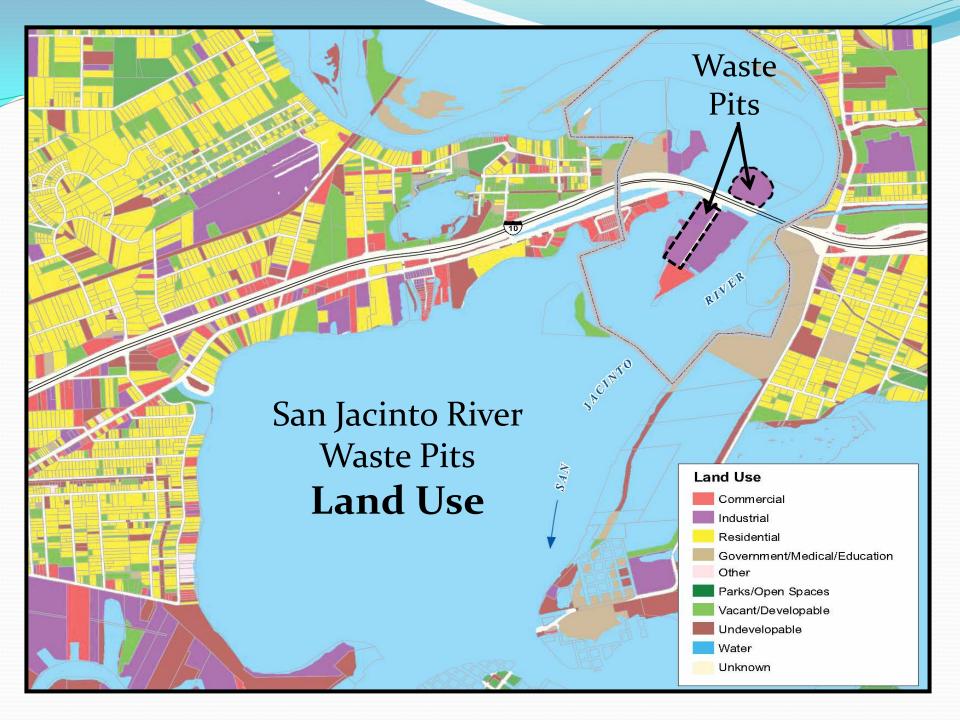
Northern Waste Pits Before Cap

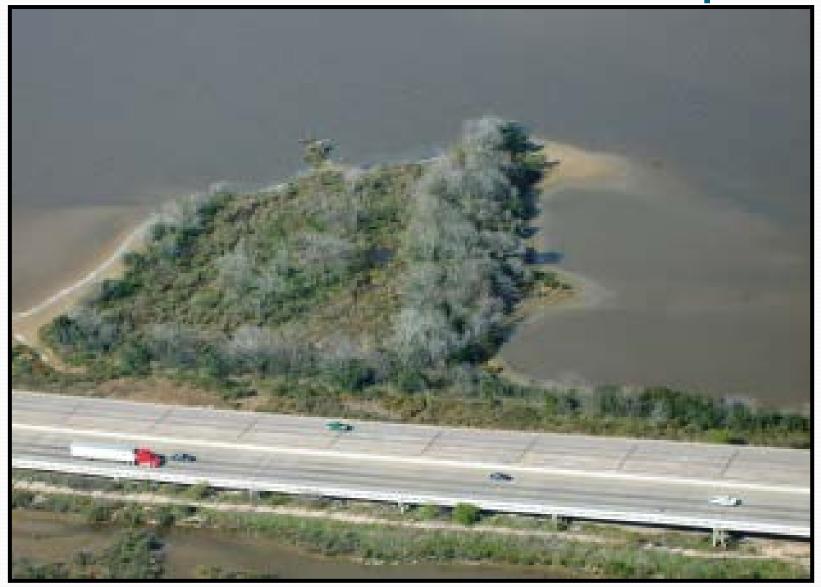
Northern Waste Pits Before Cap

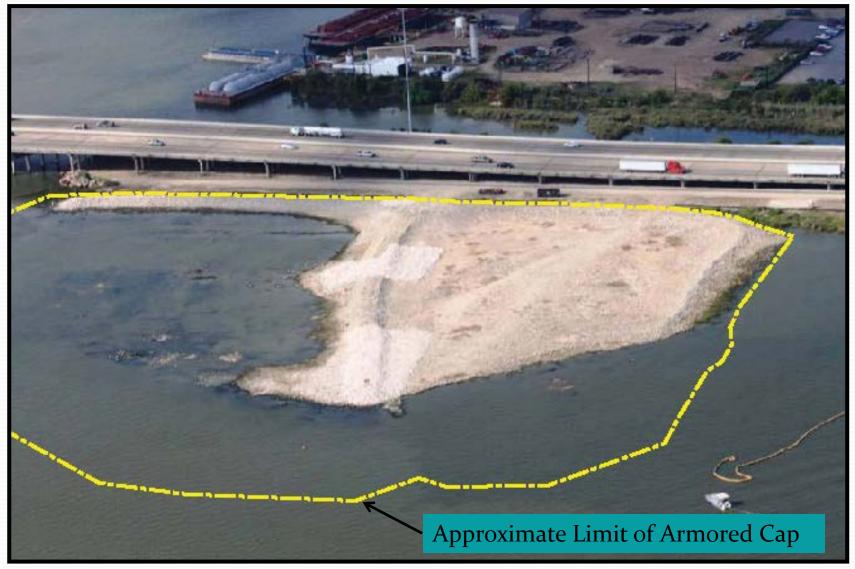
Cap Construction Completed July 12, 2011

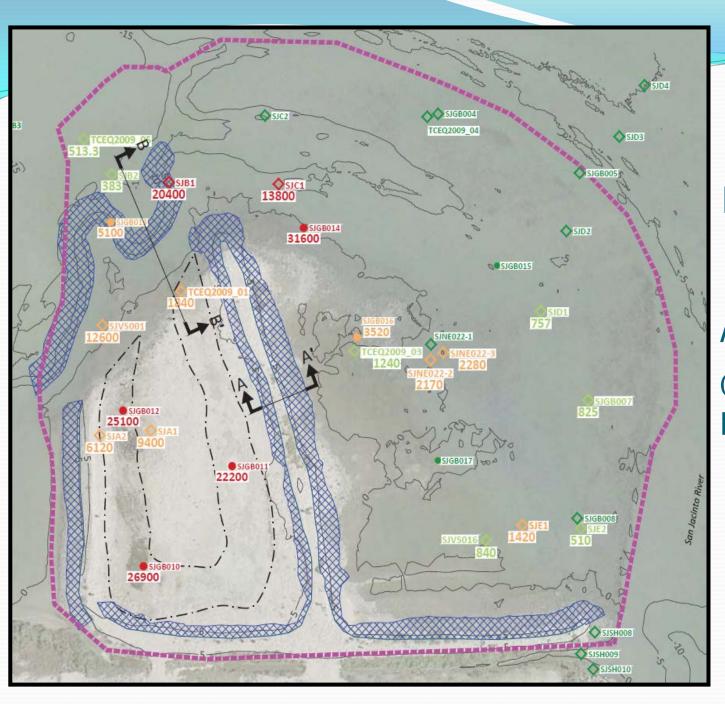
Alternative 3N Cap Enhancements:

- 2 mo.
 Construction
- \$3.5 MM

• Alt. 3N:

- Quickest construction (2 mo.).
- Least storm exposure during construction (cap not removed).
- Minimal sediment re-suspension.
- Cap: 500-year storm event design with 5-foot high rock berm outside perimeter.
- Lower cost (\$3.5 million)

- No waste removal; no treatment/removal of Principal Threat waste.
- Long term exposure to storm scour/undercut damage.
- Higher long-term maintenance costs.

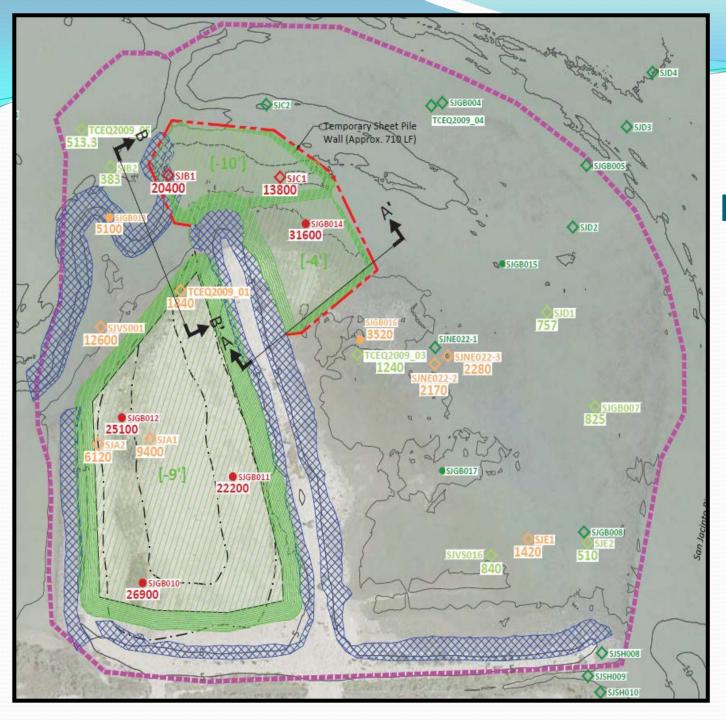
Alternative 4N

Partial Solidification (52,000 CY-29%):

- 17 mo.
 Construction
- \$ 14.2 MM

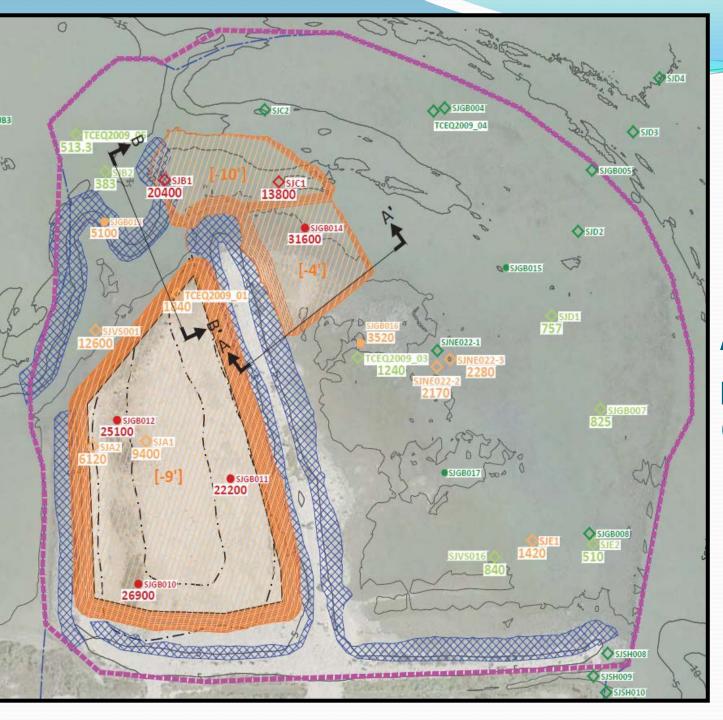
Alternative 5N

Partial Removal: (52,000 CY-29%)

- 13 mo.
 Construction
- \$29.1 MM

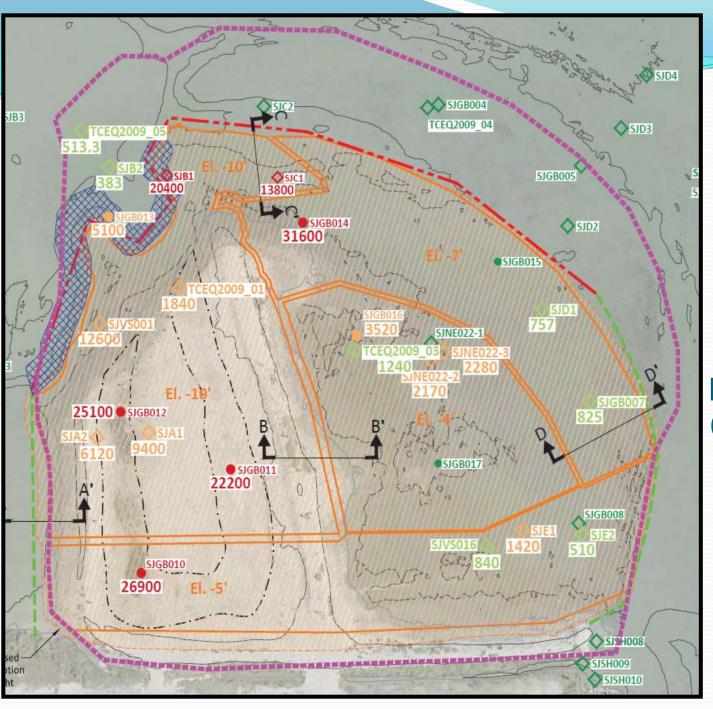
Alternative 5aN

Partial Removal (137,000 CY-76%):

- 19 mo.
 Construction
- \$68.9 MM

Alt. 5aN:

- Removes waste material with highest contamination.
- Uses sheetpiles/earthen berm during waste removal to reduce re-suspension.

- Longer construction (19 mo.) with exposure to storms (cap partially removed).
- Sediment re-suspension during dredging.
- Increased fish tissue dioxin, at least initially.
- Higher cost (\$68.9 million).

Recommended Remedy: Alternative 5aN:

- Permanently removes waste material with highest contamination.
- Uses sheetpiles and earthen berm during waste removal to reduce re-suspension, in addition to BMPs.
- Contains/protects remaining lower level material with armor cap.
- Improved long-term effectiveness compared to Alt. 1N through 5N.
- Improved short-term effectiveness compared to Alt. 6N because it has less re-suspension & less impact on fish.
- More cost effective than Alt. 6N because it addresses most of risk for \$20 MM less cost.

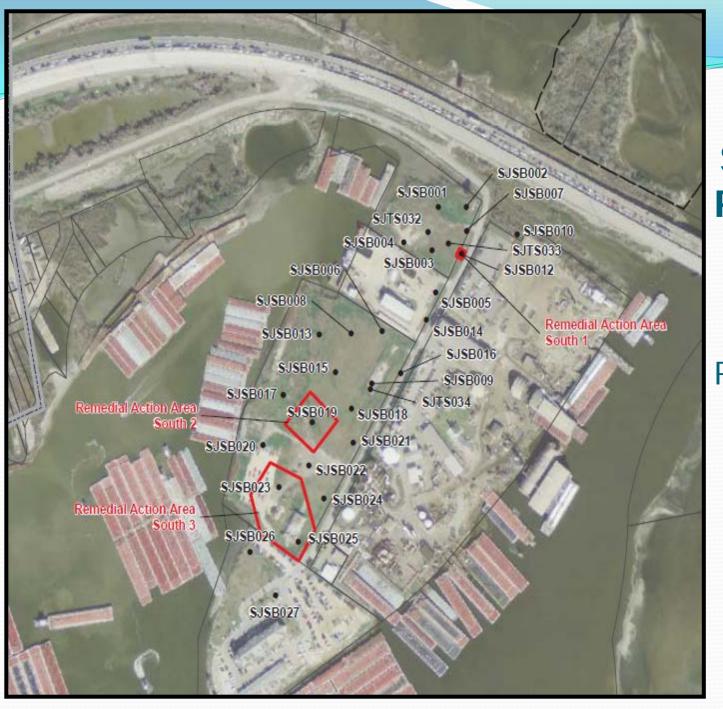
Preliminary
Remedial Action
Areas South of
I-10

- Alt. 1S: No action.
 - Cost: \$143,000.
- Alt. 2S: Institutional Controls.
 - Cost: \$273,000.
- Alt. 3S: Enhanced Institutional Controls.
 - Cost: \$663,000; 1 month construction.
- Alt. 4S: Removal & Off-Site Disposal (from 2 to 10-feet; 32,000 CY).
 - Cost: \$9.9 million; 7 months construction.

Recommended Remedy: Alternative 4S (Removal/Institutional Controls):

- Permanently removes waste material from Southern Impoundment Area.
- Uses institutional controls to provide protection for areas under buildings.
- Provides long-term protection from storm erosion/scour.

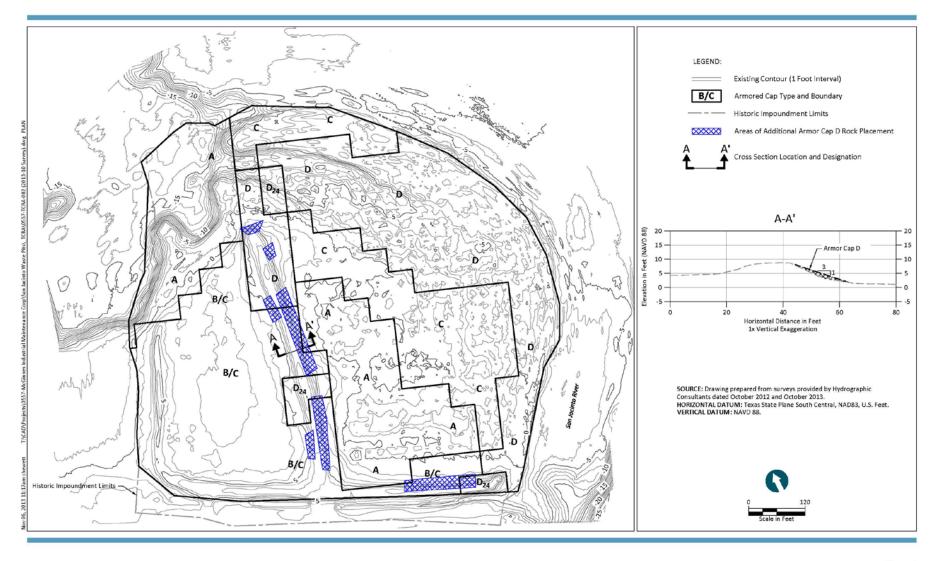
Figure 1

Armor Cap Repair Plan
San Jacinto River Waste Pits Superfund Site

Fig. 1 – Armor Cap Enhancement Work Plan - Armor cap D placement areas with improved slope construction

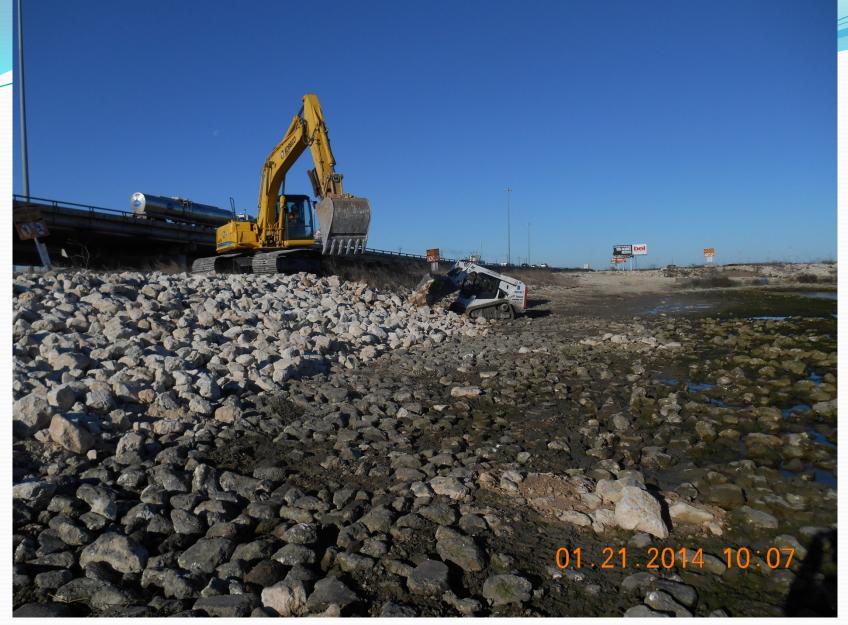
Constructing enhanced slope along the South Berm in the Eastern Cell using an excavator (for grading the rock) and skid steer (for transporting rock from the stockpile and placing it)- 1-21-2014
